Works on the Clifton Suspension Bridge include rock bolting and (opposite) parapet stanchion replacement

ROCK STEADY

Securing the long-term future of one of the world's most iconic industrial-age bridges also involves maintaining the stability of its surrounding geology. **Khalifa Bokhammas** reports from site

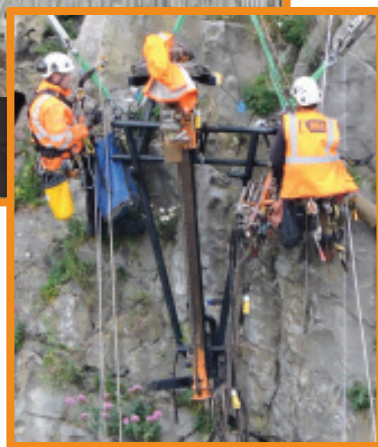
Bridge users that morning may have mistaken the four technical rope access personnel suspended on the limestone rock face beneath the tower for recreational climbers, for whom the Avon Gorge is a popular spot. A closer look, however, would have revealed a large drilling rig between two of the personnel, all part of the preparations for drilling the first of 23 holes that will house 4-6m-long rock bolts.

"Rock slopes are always split up by natural fractures; those edges of the resulting slabs that are exposed can become quite vulnerable. The bolts will all be located on the edges of these slabs, and they're just there to preserve the edges, which is part of the overall maintenance strategy," explains Summers as he points out existing rock bolts that were put in by a Bristol City engineer in 1989. "We don't have any information on them other than a drawing in the Bristol City archives showing them, so there's no way we can assess their capacity or their condition given that they are more than 30 years old, but some of our bolts are going in close to the existing ones."

Prior to their installation, a grout sock is attached to each bolt to mitigate grout loss into the joints and fissures. The bolts are then lowered into position from the bridge abutment. The need for the grout sock creates an extra challenge as it means having to assemble the whole bolt in the site compound and lower it down at its full 4-6m length rather than in smaller segments that are screwed together in the hole itself.

Other maintenance work that falls in the ambit of the five-year scheme includes the replacement of several parapet stanchions, the refurbishment of the hangers, the repainting of the chains and replacement lighting. The parapet stanchions are made of cast iron, rather than wrought iron like most of the original metal on the bridge, and 20 of them have developed cracks detected by magnetic particle inspections.

Work to replace them with spheroidal graphite cast iron replicas was due to get under way at around the time of the rock bolting but was pushed back until 19 July. "The work on the stanchions and hangers has been delayed due to Covid-19, as it requires a footway to be closed, and during lockdown we provided a one-way circulatory route on our footways for pedestrians, enabling people to cross the bridge while maintaining social distancing. Once the regulations are relaxed, we will need to close one of the footways again to continue with the work," says Trish Johnson, bridge master. "Any work that we do is of great interest to our visitors. We ensure our local neighbours are well informed in advance of any work and we have information boards detailing the work undertaken at the compound for visitors to read."
